## Performance Evaluation of Insulation and earthing Systems in Distribution Substations for Improved Overvoltage Protection: A Case Study of Distribution Substations on 11kv Ilesa Road Feeder

Department of Electrical/Electronic Engineering, Federal Polytechnic Ile-Oluji, Ondo State, Nigeria

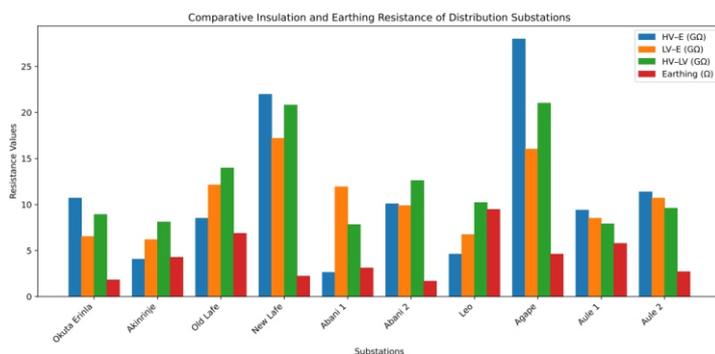
A comparison of the insulation and earthing test results highlights important operational trends, as shown in figure 1. The comparative analysis of insulation and earthing resistances across the ten substations reveals notable variations in performance. Substations such as Agape and New Lafe exhibit consistently high HV-E, LV-E, and HV-LV insulation resistances alongside low earthing resistances, indicating robust dielectric integrity and effective fault current dissipation. In contrast, Leo and Abani 1 substations demonstrate comparatively lower HV-E insulation and elevated earthing resistance, suggesting potential vulnerabilities despite acceptable overall insulation levels. The results highlight that high insulation resistance alone does not guarantee system reliability; substations require both strong insulation and effective earthing to mitigate overvoltage risks and ensure personnel safety. This cross-comparison underscores the need for targeted earthing improvements in substations where grounding performance lags behind insulation quality, thereby enhancing overall operational safety and resilience.

Figure 1. Comparative Bar Chart of Each Insulation Resistance Tests and Earthing Tests Across Substations
